## **SERVICE BULLETIN**

<b>NUMBER</b>	<b>SB1608</b>
<b>TO</b>	<b>Gogo Commercial Aircraft Services</b>
<b>SUBJECT</b>	<b>Temporary Repair to Waveguide Flex Section</b>
<b>REVISION</b>	<b>C</b>
<b>DATE</b>	<b>4/22/2016</b>

<b>DESCRIPTION</b>	<b>TX Waveguide Filter Assembly</b>
<b>PART NUMBER</b>	<b>006-15138-02, 006-15138-03, 006-1000-0001, 10211, 19498, 20488, 20663, 300-21800, 300-23887</b>

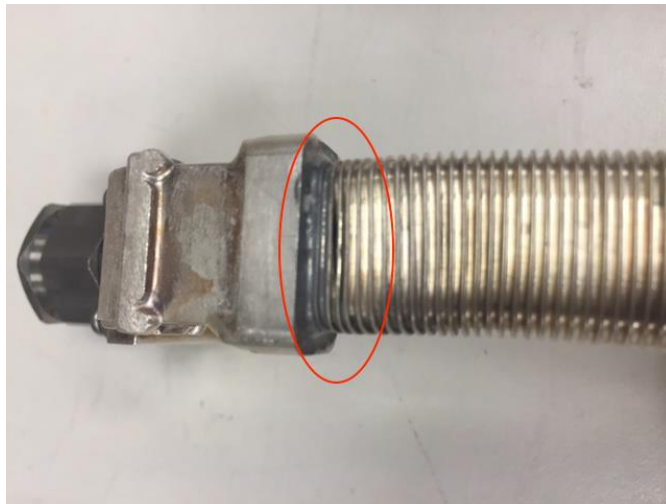
If the crack is within  $\leq 80\%$  of the waveguide circumference in length, it may be temporarily repaired by the following methods. It is acceptable to repair multiple cracks in the same waveguide section together.

Figure 1 Damaged area

- 1) Clean the Waveguide with Isopropyl alcohol wipes, ensuring the area past the ends of the flex section are clean for at least one half inch.
- 2) Use 1" or 2" Aluminum or Copper tape. Two or more pieces will be required, so overlap the edges by at least .25" and CAREFULLY apply the tape lengthwise, as far past the end of the flex section as possible. Wrap the tape around the waveguide like a sleeve. Gently form the tape bends to follow the waveguide path and adhere the overlapping edge to the first length of tape. Use a light touch only to seal the tape edges, but press firmly where the tape covers the solid sections of the waveguide. (see Figures 1 through 5 below)

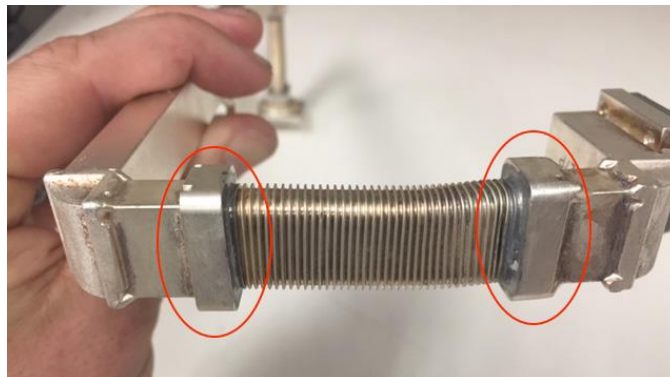
Figure 2 Area to be Cleaned and tape adhered to

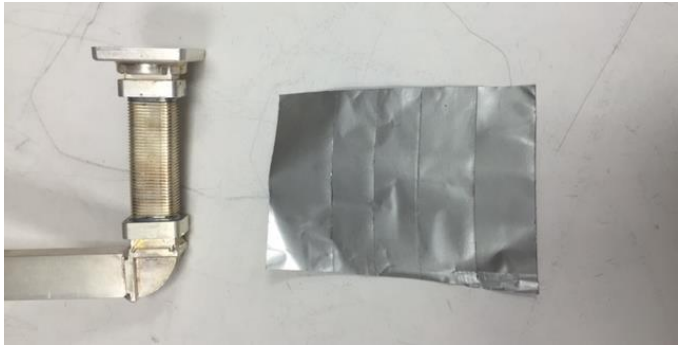
Figure 3 Tape pieces joined together

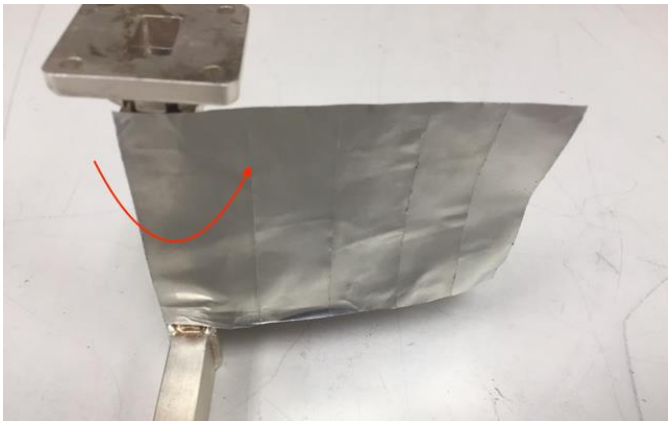
Figure 4 Application of the tape

**CAUTION:** DO NOT pinch or press the tape against the waveguide except at each end where the waveguide is solid. Excess pressure may deform the waveguide flex section requiring immediate replacement.

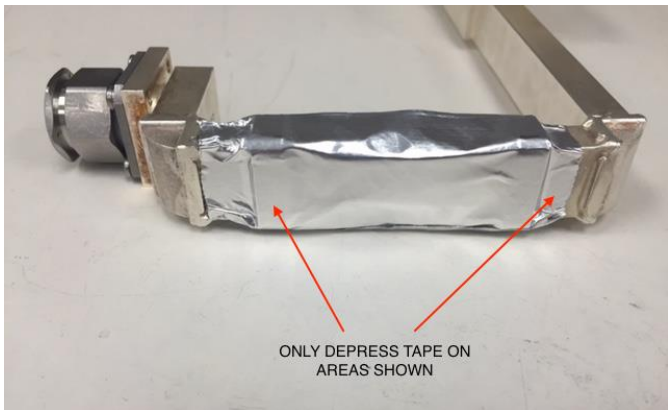
Figure 5 securing the tape in place
