NUMBER	SIL1604
TO	ALL F-Series (HR6400) Maintenance and Installation Personnel
SUBJECT	Improper TX Waveguide Filter Installation
REVISION	Rev C
DATE	08/22/18

DESCRIPTION	TX Waveguide Filter Assembly
PART NUMBER(S)	006-15138-02, 006-15138-03, 006-1000-0001, 10211, 19498, 20488, 20663, 300-21800, 300-23887, 300-68132
PART NUMBER REVISION	ALL

ISSUE DESCRIPTION

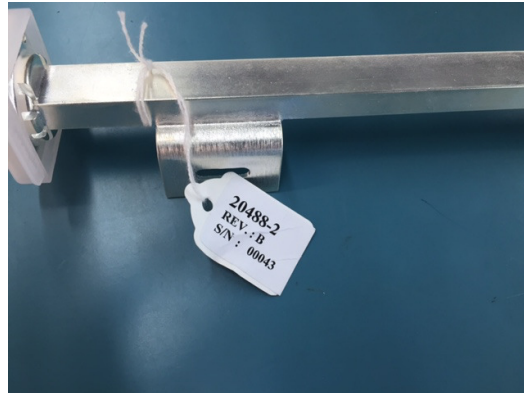
identified as such. The serial number is marked on the component or on an attached tag. See Figure 1 for an example of a component with a serial number tag.

Figure 1 Serial Number Tag Example

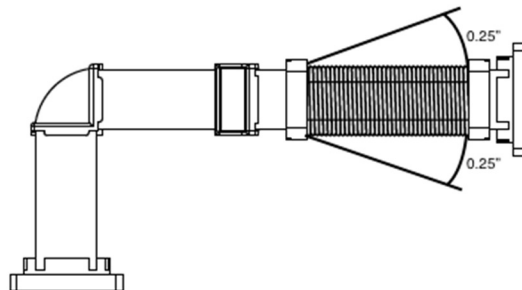
4. The flex section of the TX Waveguide Filter Assembly is not designed to be used to compensate for installation error. The flex section **shall not** be deflected more than 0.25 inches in any direction in the installed state (see Figure 2). This section is intended only for deflection needed for the removal and installation of the Line Replaceable Units (LRUs) it connects to.

Figure 2 Flex Section Deflection

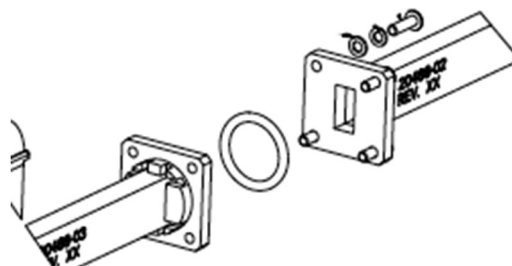
5. Installation of all O-Rings (Packing) **shall** be accomplished in accordance with the installation design and manufacturer instructions. Not installing the appropriate O-Ring will cause degraded system performance. See Figure 3 for an example of an O-Ring installation.

Figure 3 O-Ring Installation

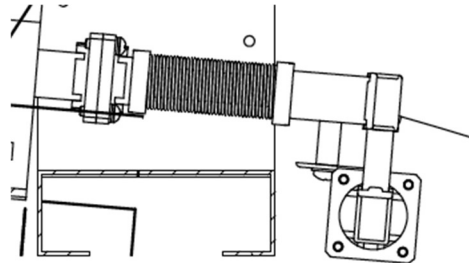
- Bending or modifying the TX Waveguide Filter Assembly **shall not** be performed to accommodate installations. Modification of the TX Waveguide Filter Assembly can cause damage and/or impact system performance. See Figure 4 for an example of a properly installed Waveguide.

Figure 4 Properly Installed Waveguide

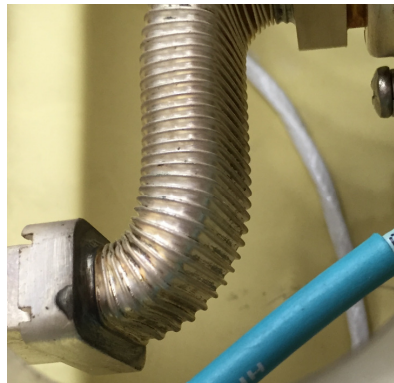
- Only the minimal required deflection of the flex section of the TX Waveguide Filter Assembly **shall** be used in removal and installation of LRUs. Excessive bending of the flex section can cause damage to the Waveguide. Any deflection for LRU removal and installation **shall not** introduce sharp turns to the flex section as damage will occur. See Figure 5 for an example of excessive bending on the flex section.

Figure 5 Excessive Bending of the Flex Section

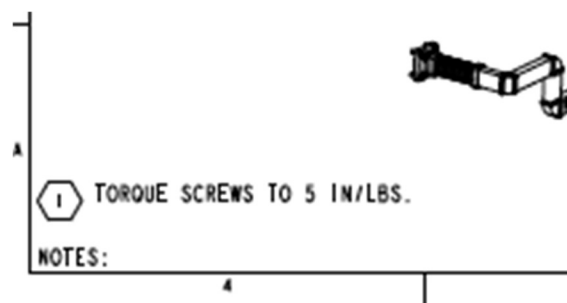
- All hardware used **shall** be in accordance with the installation design and manufacturer instructions. This hardware **shall** be torqued to the appropriate specified values. See Figure 6 for an example of torque callout.

Figure 6 Torque Callout Example

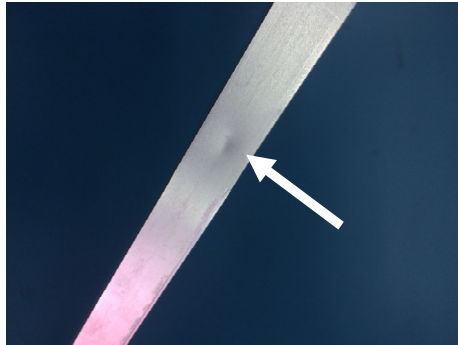
- Evidence of tuning dents on the flat sections of the TX Waveguide Filter Assembly may be present. These dents will have soft edges (see Figure 7). The small soft edged dents are for the tuning of the TX Waveguide Filter Assembly to optimize performance of the component.

Figure 7 Tuning Dent Displayed
